**SUMMERFIELD VILLAGE HOA**  
**Association #: 01.01.2561**

**Level 1 -- Full Reserve Study with Site Visit**

**Prepared By: Byron Goetting**

**Date of Site Inspection: 12/15/2022**

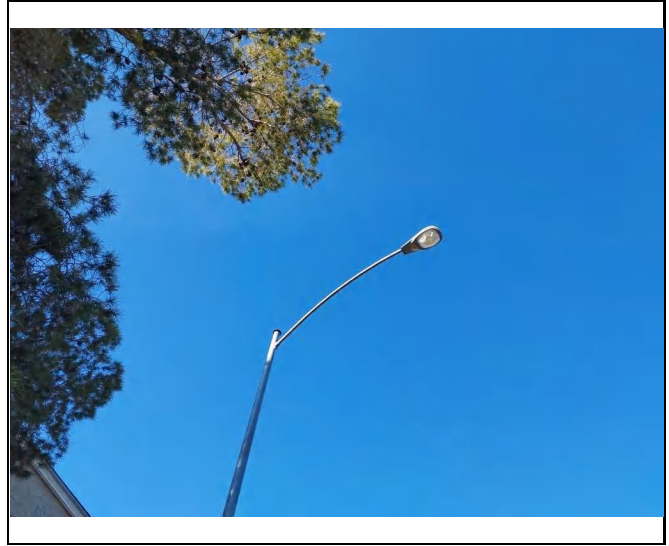
**Comp #: 1.111 Street Light Fixtures - Replace**

<b>Evaluation:</b>	No problems with these street light fixtures noted at time of site visit. However, this community should regularly inspect these lights during nighttime hours to check for any issues.		
<b>Quantity Notes:</b>

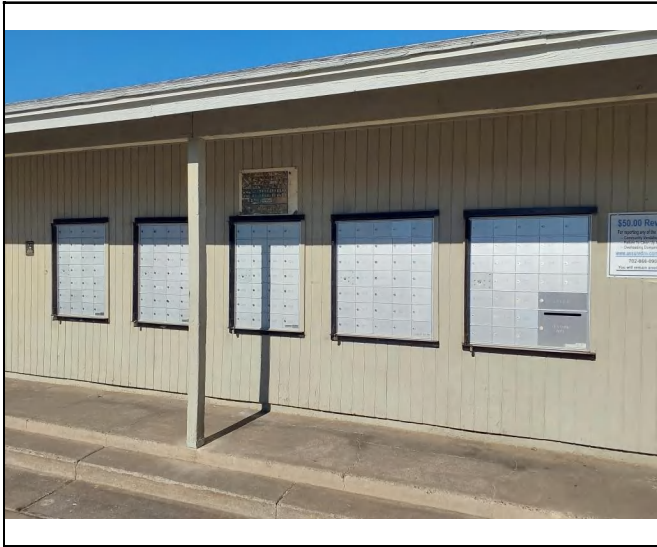
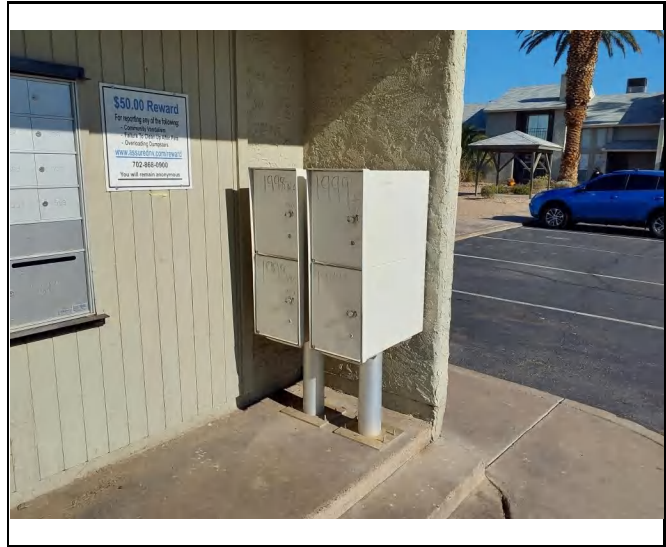
**Comp #: 1.117 Mailbox Cluster Box Units (CBUs) - Replace**

<b>Evaluation:</b>	Usually these CBUs will show some minor cosmetic issues such as faded or peeling paint. However, no major functionality problems were noted at time of site visit.		
<b>Quantity Notes:</b>

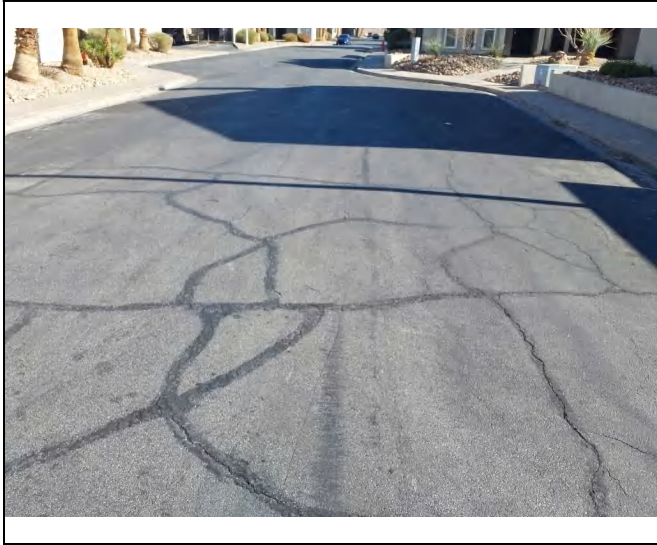
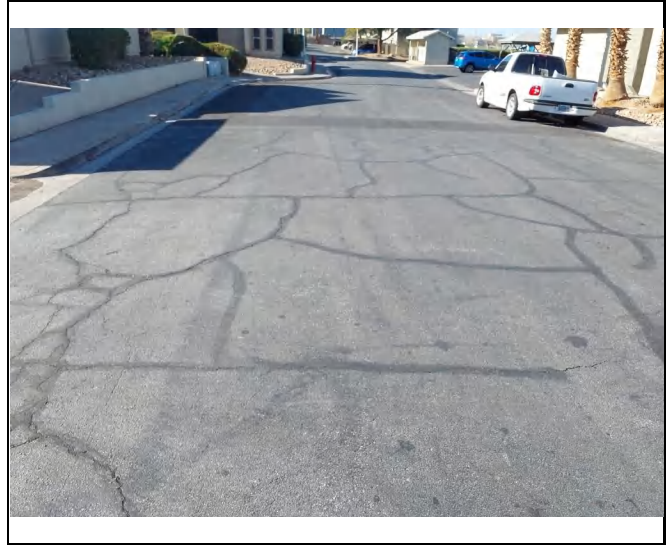
**Comp #: 1.201 Asphalt - Major Rehab**

<b>Evaluation:</b>	This asphalt is aging normally and showing signs of distress. This community should begin to make plans for a major asphalt project.		
<b>Quantity Notes:</b>

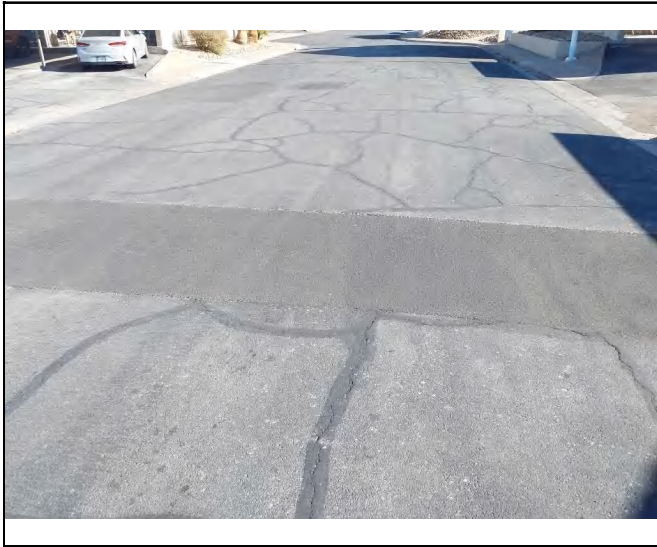
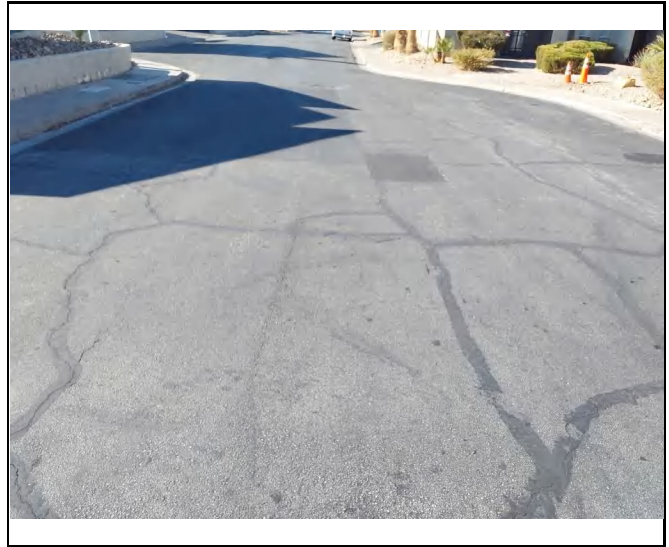
**Comp #: 1.202 Asphalt - Preservation**

<b>Evaluation:</b>	As the asphalt begins to age, this community should work with an asphalt professional to determine an appropriate plan.		
<b>Quantity Notes:</b>

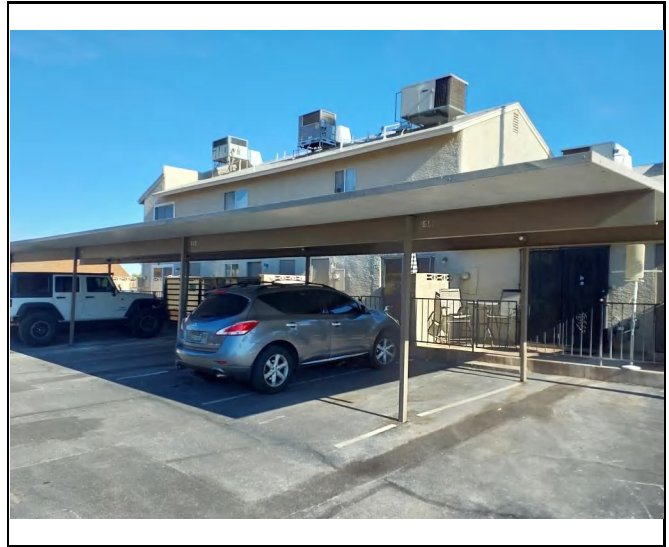
**Comp #: 1.216 Carports - Repair/Replace**

<b>Quantity:</b>	1 Allowance	<b>Original Service Date:</b>	2019
<b>Unit Cost:</b>	\$35,000.00	<b>Useful Life:</b>	10
<b>% of Unit Cost:</b>	100.0%	<b>Rem. Useful Life Adjustment:</b>	0
<b>Total Cost:</b>	\$35,000.00	<b>Remaining Useful Life:</b>	6
<b>Cost Source:</b>	GeoReserves Database		
<b>Description:</b>	This component funds to make any repairs, replacements, and repainting to the carports. This includes the carport light fixtures and any other related work. This work should be done every 10 years or when necessary.		
<b>Evaluation:</b>	No major problems noted.		
<b>Quantity Notes:</b>

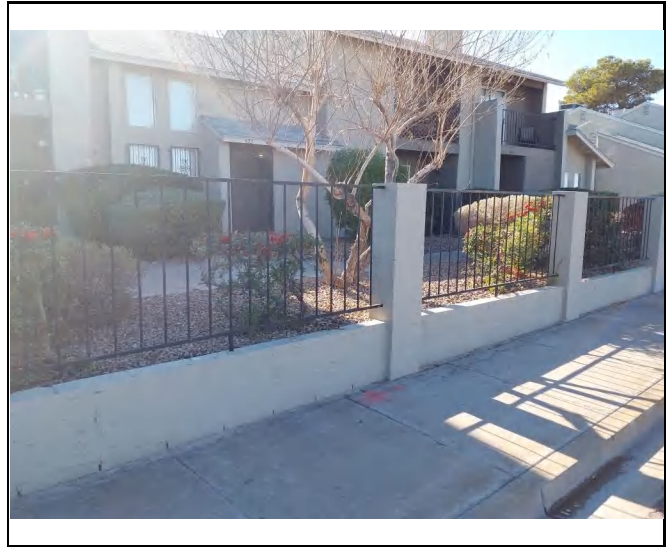
**Comp #: 1.305 Wrought Iron Fencing - Replace**

<b>Quantity:</b>	300 Linear ft.	<b>Original Service Date:</b>	1988
<b>Unit Cost:</b>	\$55.00	<b>Useful Life:</b>	30
<b>% of Unit Cost:</b>	100.0%	<b>Rem. Useful Life Adjustment:</b>	14
<b>Total Cost:</b>	\$16,500.00	<b>Remaining Useful Life:</b>	9
<b>Cost Source:</b>	GeoReserves Database		
<b>Description:</b>	Although this fencing is referred to as wrought iron, it is typically hollow metal that has been rolled and made to give a classic wrought iron look. With regular painting and maintenance, this fencing should last approximately 30 years.		
<b>Evaluation:</b>	No major rusting, bent areas or other damage noted.		
<b>Quantity Notes:</b>

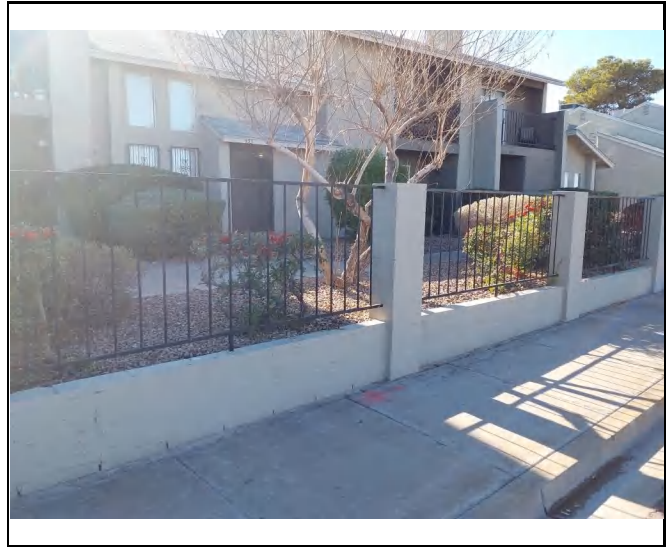
**Comp #: 1.306 Wrought Iron Fencing - Repair/Repaint**

<b>Quantity:</b>	300 Linear ft.	<b>Original Service Date:</b>	2019
<b>Unit Cost:</b>	\$14.00	<b>Useful Life:</b>	6
<b>% of Unit Cost:</b>	100.0%	<b>Rem. Useful Life Adjustment:</b>	0
<b>Total Cost:</b>	\$4,200.00	<b>Remaining Useful Life:</b>	2
<b>Cost Source:</b>	GeoReserves Database		
<b>Description:</b>	This component includes painting the metal fencing, along with making any repairs to bent or rusted areas. This project should be performed every 6 years or when necessary to maintain appearance and ensure the fence realizes a full useful life. Different paint materials and techniques will determine the actual useful life and may result in adjusting this schedule.		
<b>Evaluation:</b>	No significant rusting or faded paint noted.		
<b>Quantity Notes:</b>

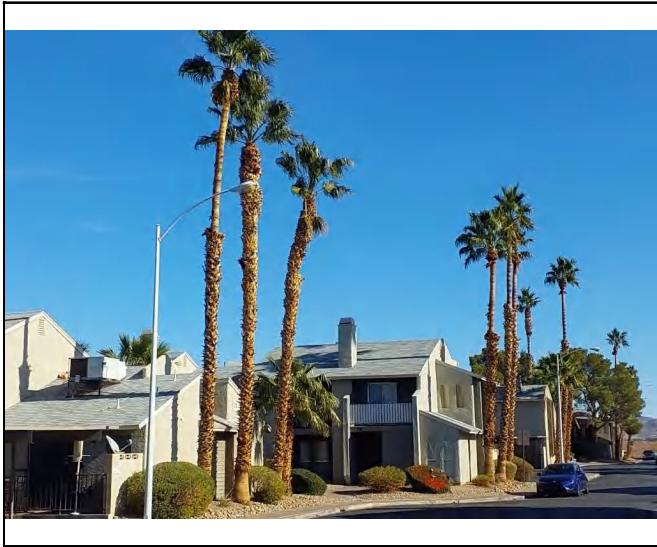
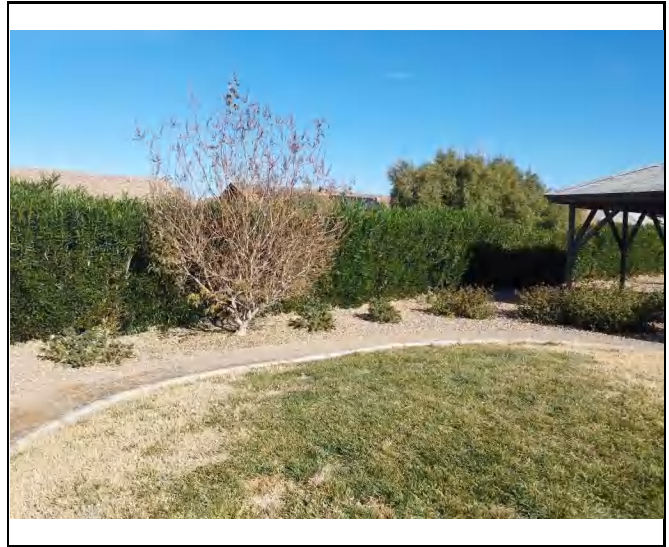
**Comp #: 1.401 Landscaping - Renovate**

<b>Evaluation:</b>	No major appeance concerns noted. This landscaping should be maintained on a regular basis and the association should work with the landscaper to determine any specific areas of improvement that go beyond the normal maintenance contract.		
<b>Quantity Notes:</b>

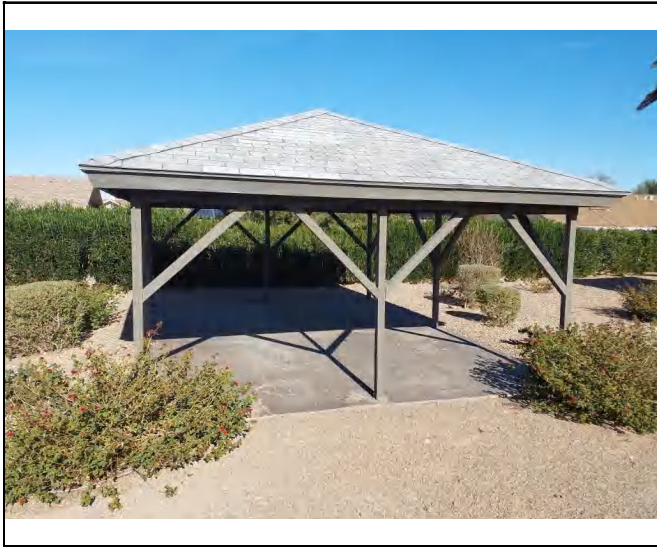
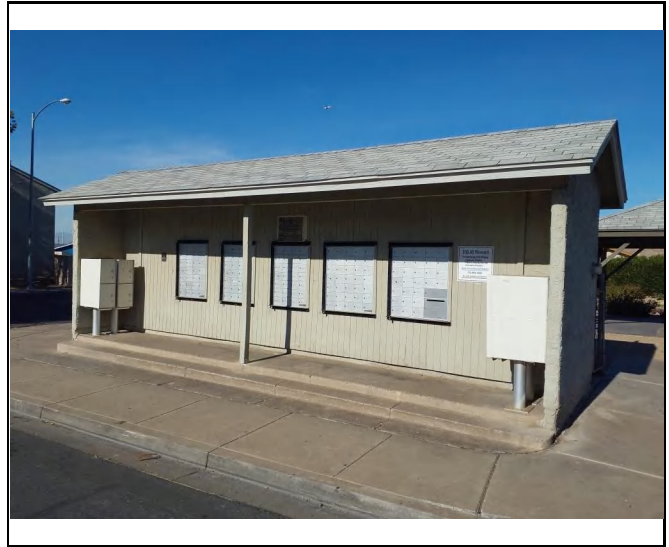
**Comp #: 1.614 Shade/Mailbox Structures - Rebuild**

<b>Quantity:</b>	6 Structures	<b>Original Service Date:</b>	1988
<b>Unit Cost:</b>	\$15,000.00	<b>Useful Life:</b>	40
<b>% of Unit Cost:</b>	100.0%	<b>Rem. Useful Life Adjustment:</b>	5
<b>Total Cost:</b>	\$90,000.00	<b>Remaining Useful Life:</b>	10
<b>Cost Source:</b>	GeoReserves Database		
<b>Description:</b>	This component funds for a major rebuild project of the shade structures and mailbox building. This work should be done every 30 years or longer to maintain appearance and functionality standards.		
<b>Evaluation:</b>	No problems noted.		
<b>Quantity Notes:</b>

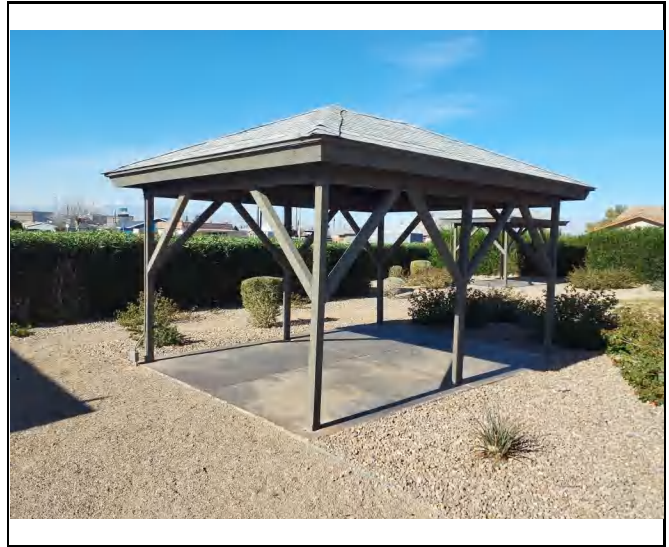
**Comp #: 1.616 Shade/Mailbox Structures - Repaint/Repair**

<b>Quantity:</b>	6 Structures	<b>Original Service Date:</b>	2013
<b>Unit Cost:</b>	\$1,500.00	<b>Useful Life:</b>	10
<b>% of Unit Cost:</b>	100.0%	<b>Rem. Useful Life Adjustment:</b>	0
<b>Total Cost:</b>	\$9,000.00	<b>Remaining Useful Life:</b>	0
<b>Cost Source:</b>	GeoReserves Database		
<b>Description:</b>	This component funds to paint and make other repairs or replacements to the shade structures and mailbox building. This includes replacing any light fixtures, repairs to the roofs, or other related work.		
<b>Evaluation:</b>	Remaining life based on current schedule.		
<b>Quantity Notes:</b>

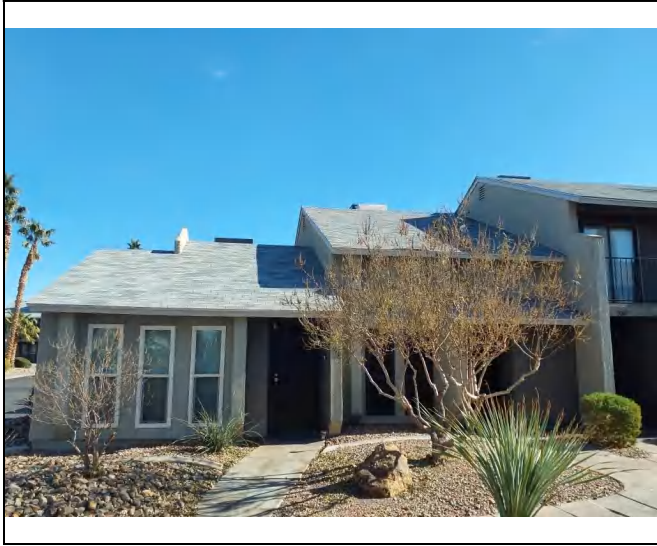
**Comp #: 2.1004 Asphalt Shingle Roof - Replace**

<b>Quantity:</b>	100,000 Sq.ft.	<b>Original Service Date:</b>	2017
<b>Unit Cost:</b>	\$5.00	<b>Useful Life:</b>	30
<b>% of Unit Cost:</b>	100.0%	<b>Rem. Useful Life Adjustment:</b>	0
<b>Total Cost:</b>	\$500,000.00	<b>Remaining Useful Life:</b>	24
<b>Cost Source:</b>	GeoReserves Database		
<b>Description:</b>	This component funds to replace the asphalt shingle roof. These roofs have a useful life of anywhere between 30 and 50 years depending on the material used. This community should have annual maintenance done and this cost schedule can be revised based on recommendations of their regular roofing contractor.		
<b>Evaluation:</b>	No problems reported. Remaining life based on reported age.		
<b>Quantity Notes:</b>

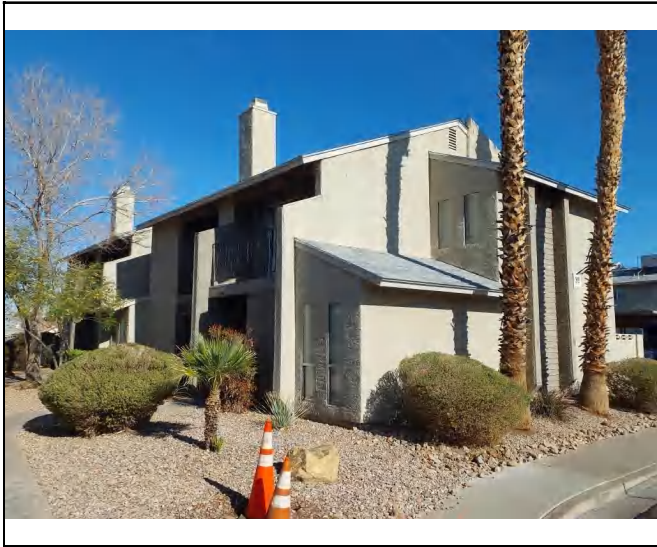
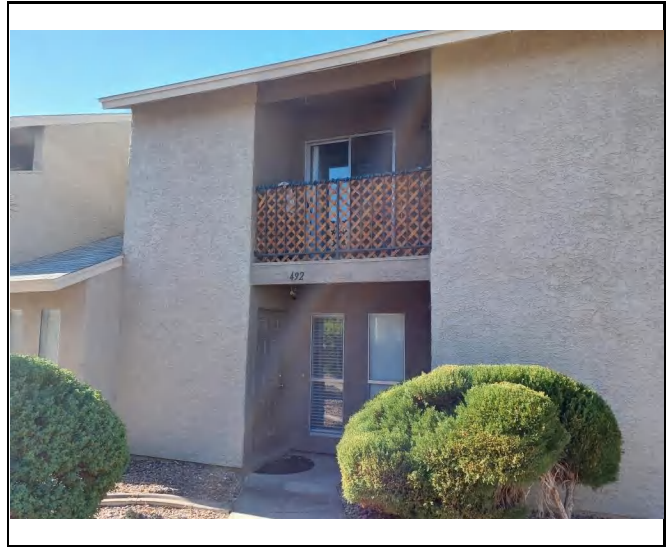
**Comp #: 2.1102 Stucco Siding - Repaint/Repair**

<b>Quantity:</b>	143 Units	<b>Original Service Date:</b>	2018
<b>Unit Cost:</b>	\$2,000.00	<b>Useful Life:</b>	10
<b>% of Unit Cost:</b>	100.0%	<b>Rem. Useful Life Adjustment:</b>	0
<b>Total Cost:</b>	\$286,000.00	<b>Remaining Useful Life:</b>	5
<b>Cost Source:</b>	GeoReserves Database		
<b>Description:</b>	This component funds to repaint the stucco surfaces and make any related repairs. There are several different scopes of work that can be performed for this project. Painting can be done with acrylic, elastomeric, or other types of paint. Also, a fog coating can be performed depending on the age and condition of stucco. This component funds to repaint the stucco every 10 to 12 years, but input should be provided by a stucco and/or paint professional at the time this project is scheduled to occur.		
<b>Evaluation:</b>	No major problems noted.		
<b>Quantity Notes:</b>

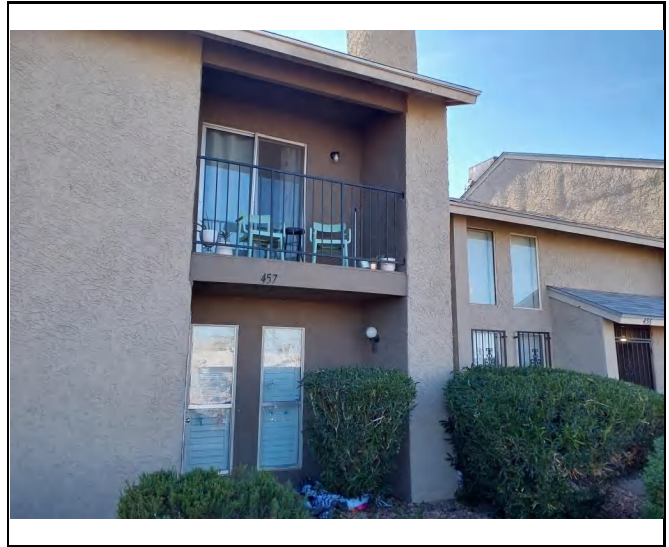
**Comp #: 2.1104 Misc. Building Surfaces - Repaint/Repair**

<b>Quantity:</b>	143 Units	<b>Original Service Date:</b>	2018
<b>Unit Cost:</b>	\$300.00	<b>Useful Life:</b>	5
<b>% of Unit Cost:</b>	100.0%	<b>Rem. Useful Life Adjustment:</b>	0
<b>Total Cost:</b>	\$42,900.00	<b>Remaining Useful Life:</b>	0
<b>Cost Source:</b>	GeoReserves Database		
<b>Description:</b>	This component includes making minor touch-up repair and painting to the stucco surfaces, as well as painting the building railings, wood trim, and other miscellaneous surfaces. This work should be done every 5 to 6 years.		
<b>Evaluation:</b>	Remaining life based on current schedule.		
<b>Quantity Notes:</b>
